Geomorphology and River Hydraulics of the Teton River Upstream of Teton Dam Teton River, Idaho

U.S. Department of the Interior
Bureau of Reclamation

May 2000

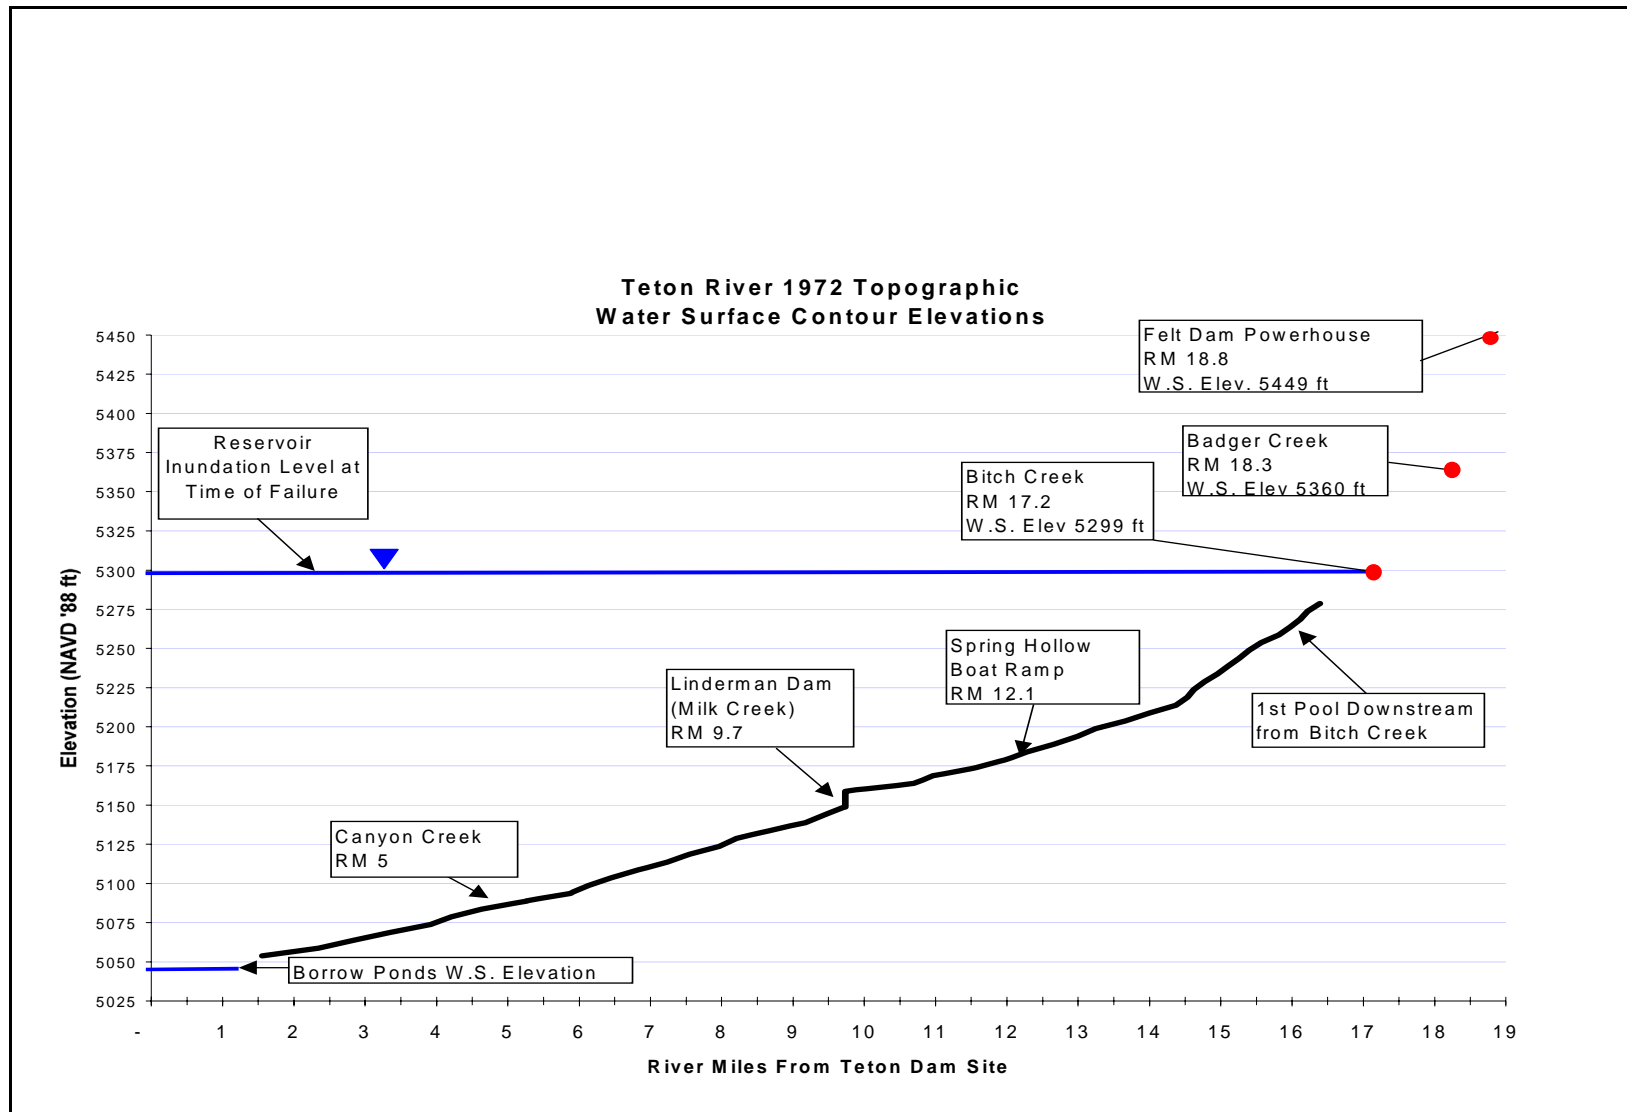
Figure 2.-Teton River orientation graph showing 1972 water surface elevation contours and the 1976 reservoir inundation reach.

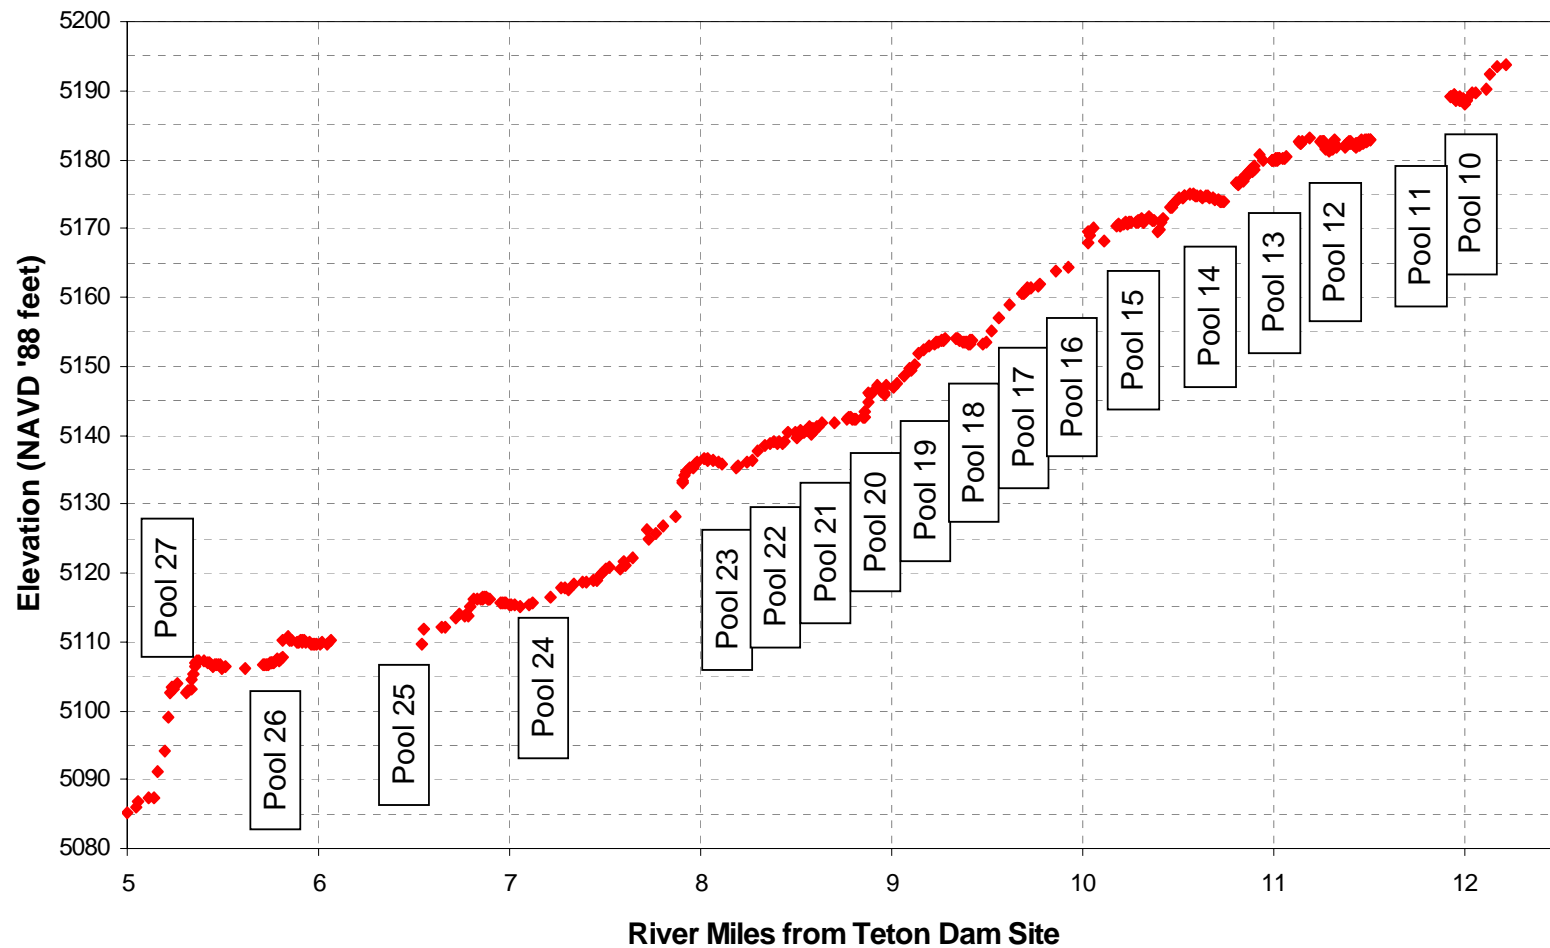
To check the accuracy of the survey, the vertical coordinates of the 1997 Spring Hollow to Canyon Creek survey data were plotted by river mile (figure 3). In contrast to field observations of relatively flat pools that dropped slightly in elevation in the downstream direction, measured water surface elevations through pools tended to rise slightly in the downstream direction, and fluctuated up to ± 1 foot across any transverse line in a pool. This measurement error was due to the limitations of the instrument and the difficulty in tracking the moving raft, thus limiting the vertical precision of the survey measurement. This vertical error was corrected for calibration purposes by determining the average water surface elevation across each pool to eliminate the vertical fluctuations. The vertical coordinates of the 1999 Bitch Creek to Spring Hollow survey data were also plotted by river mile (figure 4). A new survey instrument used in this reach eliminated the ± 1 -foot fluctuations caused by the previous survey instrument.

Figure 3.—Measured (1997) water surface profile for Teton River from Spring Hollow to confluence with Canyon Creek.

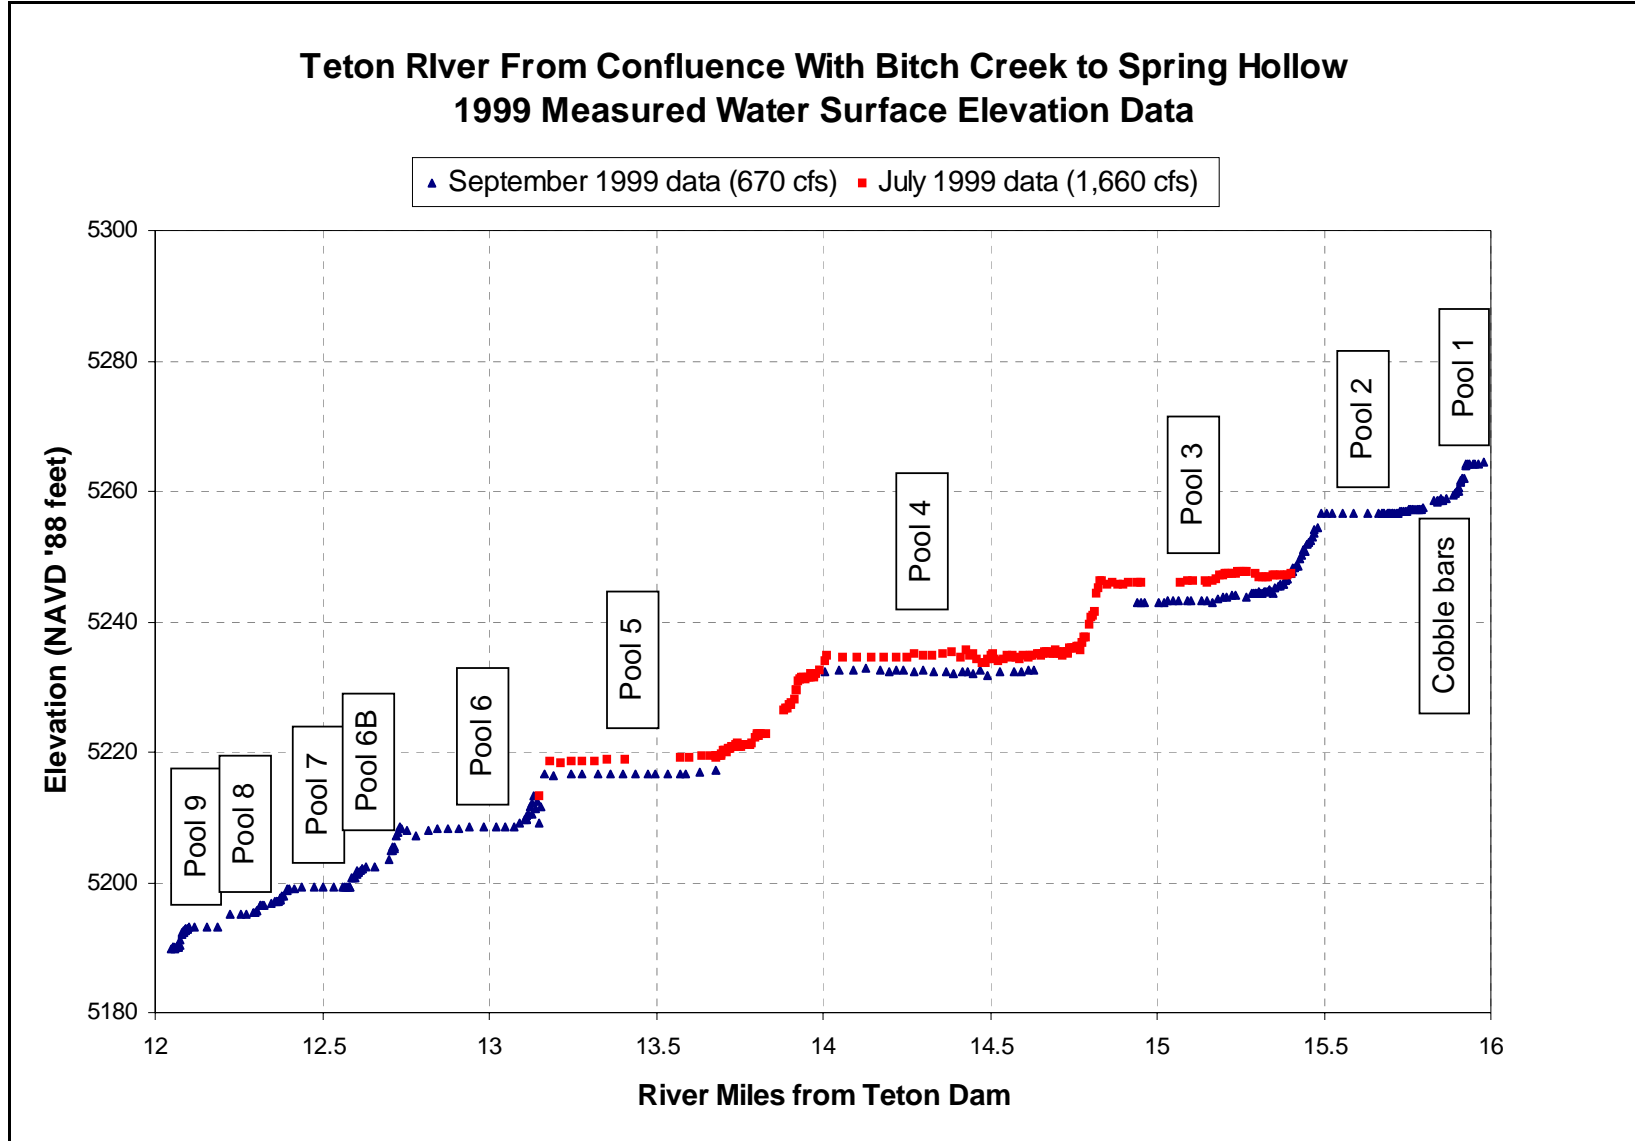
Figure 4.—Measured (1999) water surface profile for Teton River from confluence with Bitch Creek to Spring Hollow.

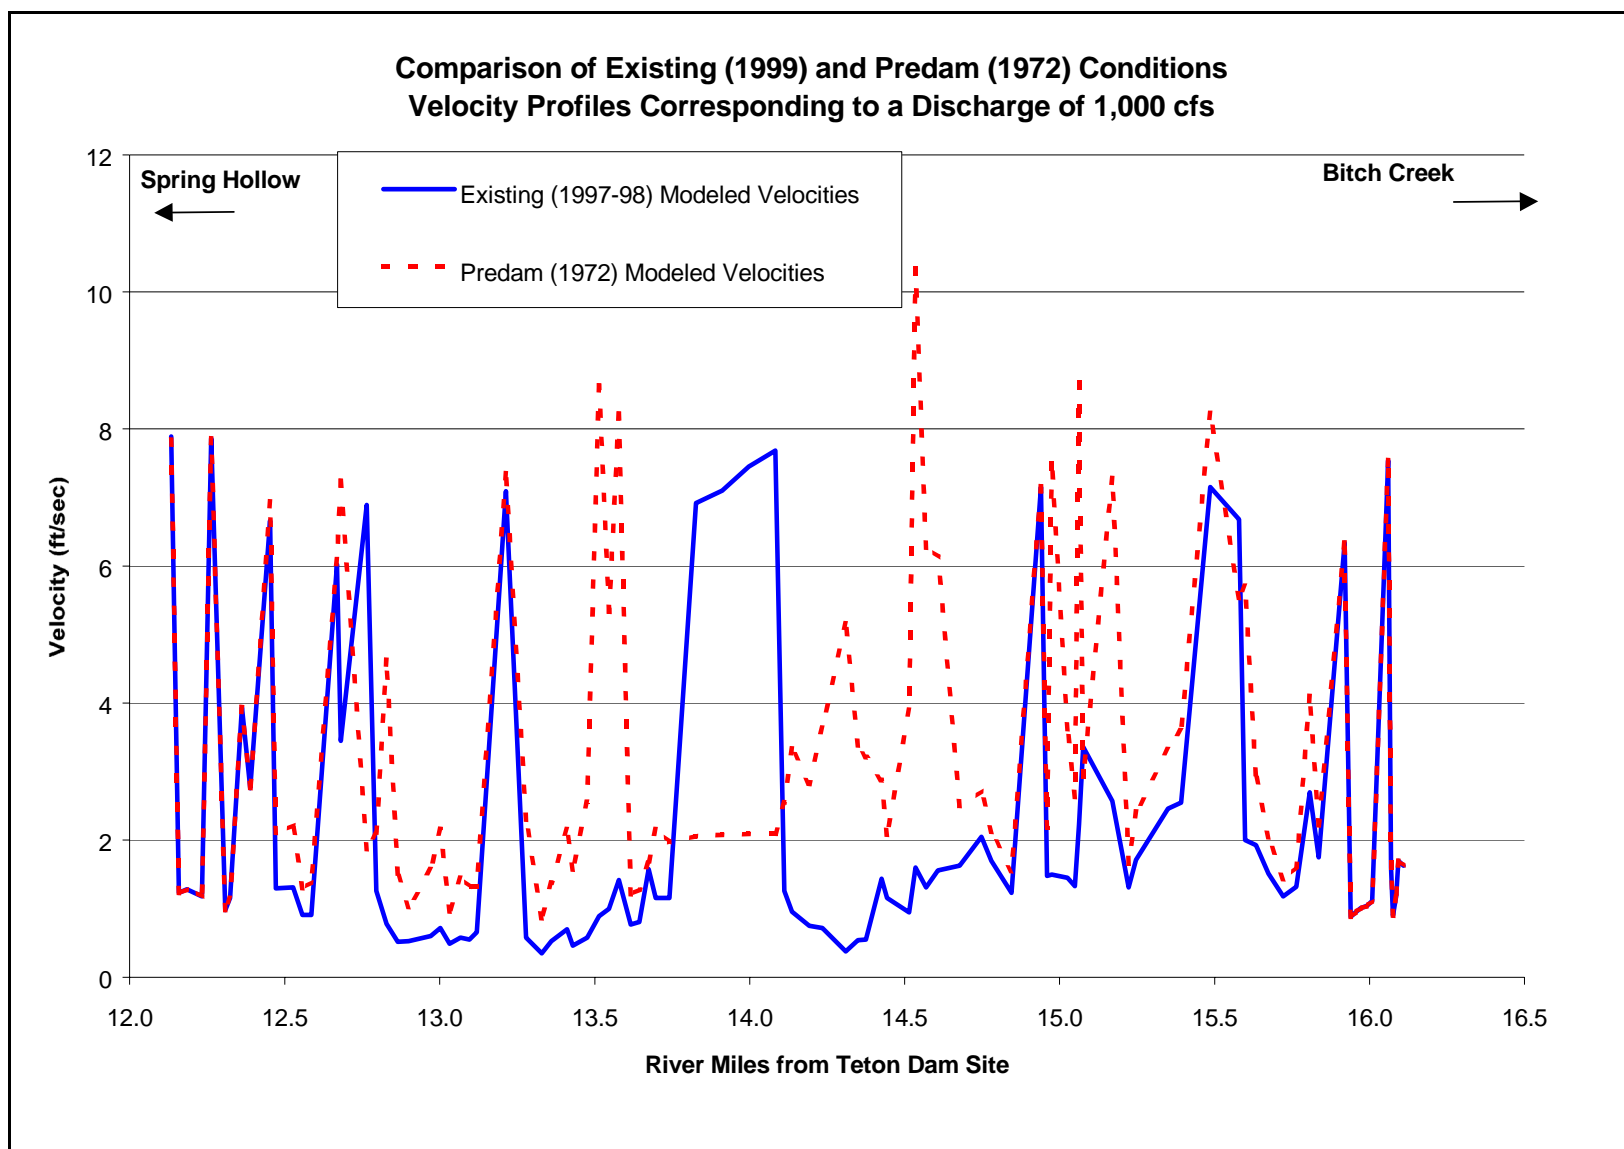
The mean velocity versus river mile was plotted for the 1997 and 1972 conditions at 1,000 cubic feet per second (figures 8 and 9). In pools 1, 8, and 9 (RM 16.1, and RM 12.1 to 12.4, respectively), the predam velocities are identical to existing conditions, indicating that these pools existing to near the same depths at which they exist today. In pools 2-7 (RM 12.5 to 15.8), the predam velocities were higher than existing conditions. The velocity profiles indicate several riffles served as hydraulic controls in these pools in 1972, in different locations than some of the 1976 landslides. These riffles are now inundated, due to the raised water surface elevation of the pools as a result of the 1976 landslides. The predam velocities are slightly higher in pools 10 to 13 (RM 12.1-10.9) and pools 18 to 22 (RM 9.7-8.4), and slightly lower in pools 14 to 16 (RM 10.8-9.9), where Linderman Dam was backing up water in 1972. Downstream from pool 22 (RM 8.5-5.3), velocities in the predam model are up to 6 feet per second higher than under existing conditions. This is because the rapids forming these pools were not present in 1972.

Figure 8.—Comparison of existing (1999) and predam (1972) velocity profiles (RM 12.1 to 16.1).

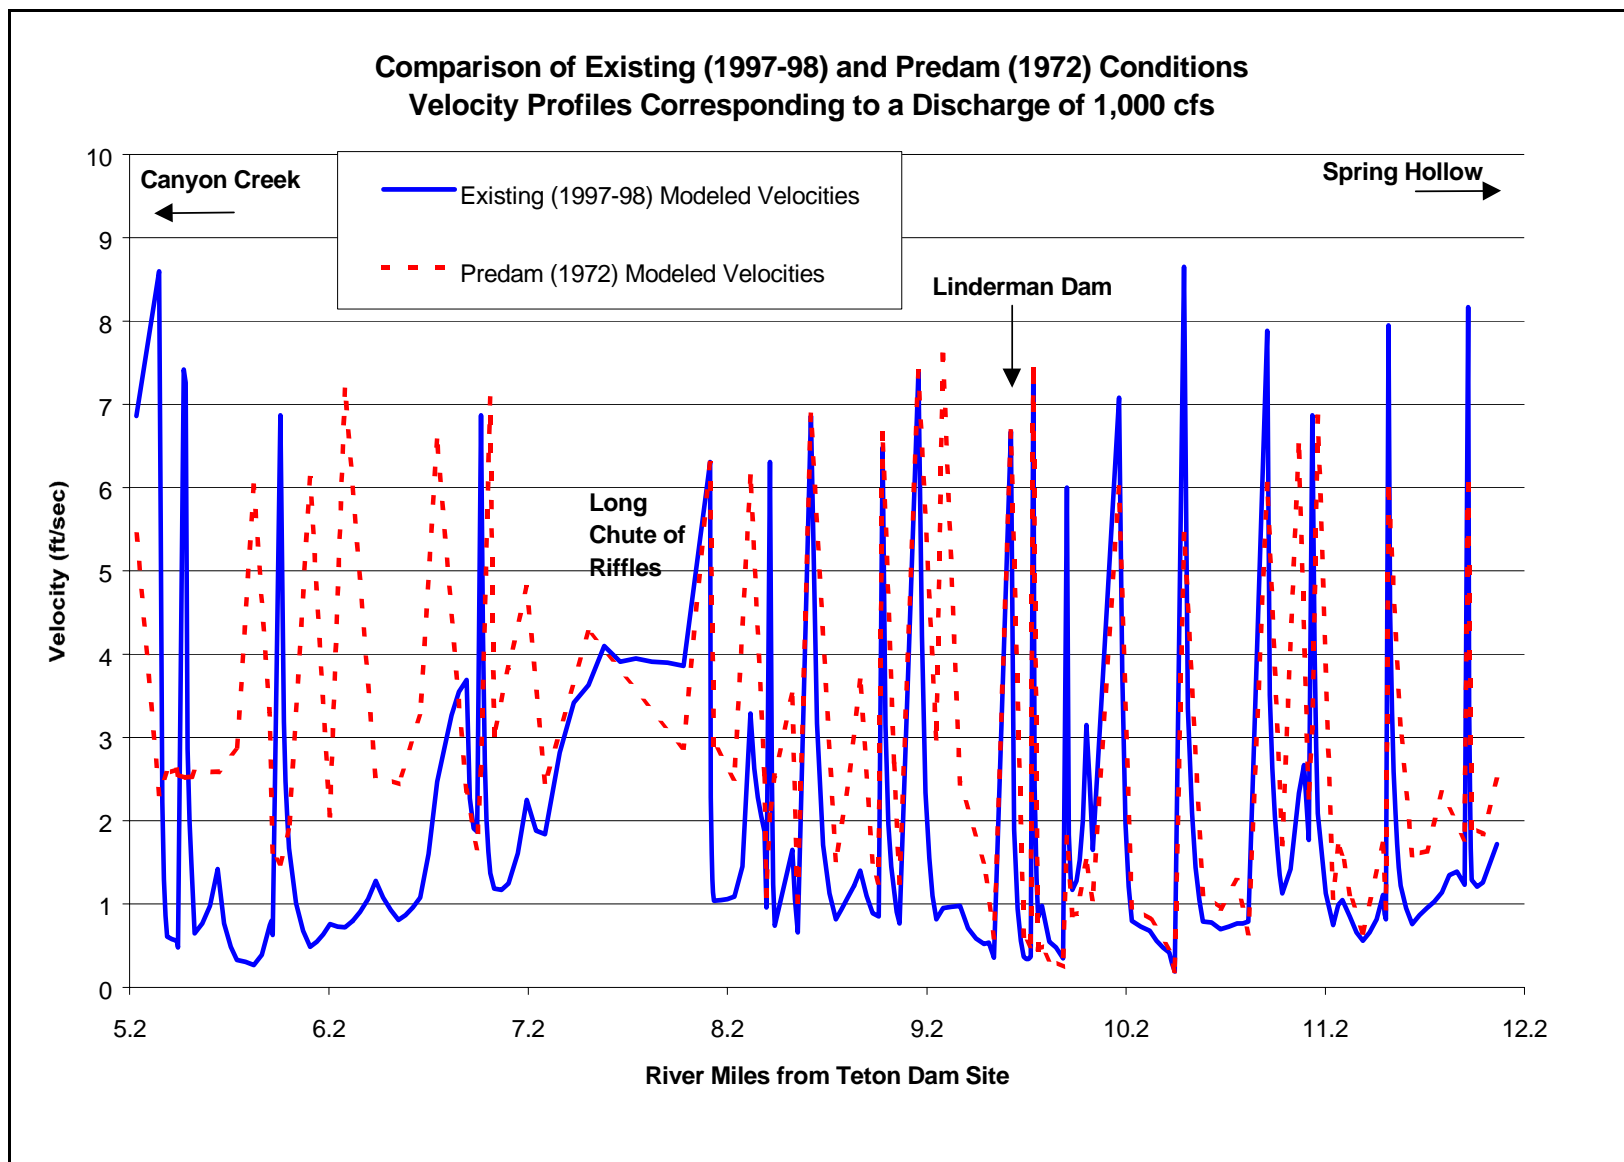
Figure 9.—Comparison of existing (1997-98) and predam (1972) velocity profiles (RM 5 to 12.1).

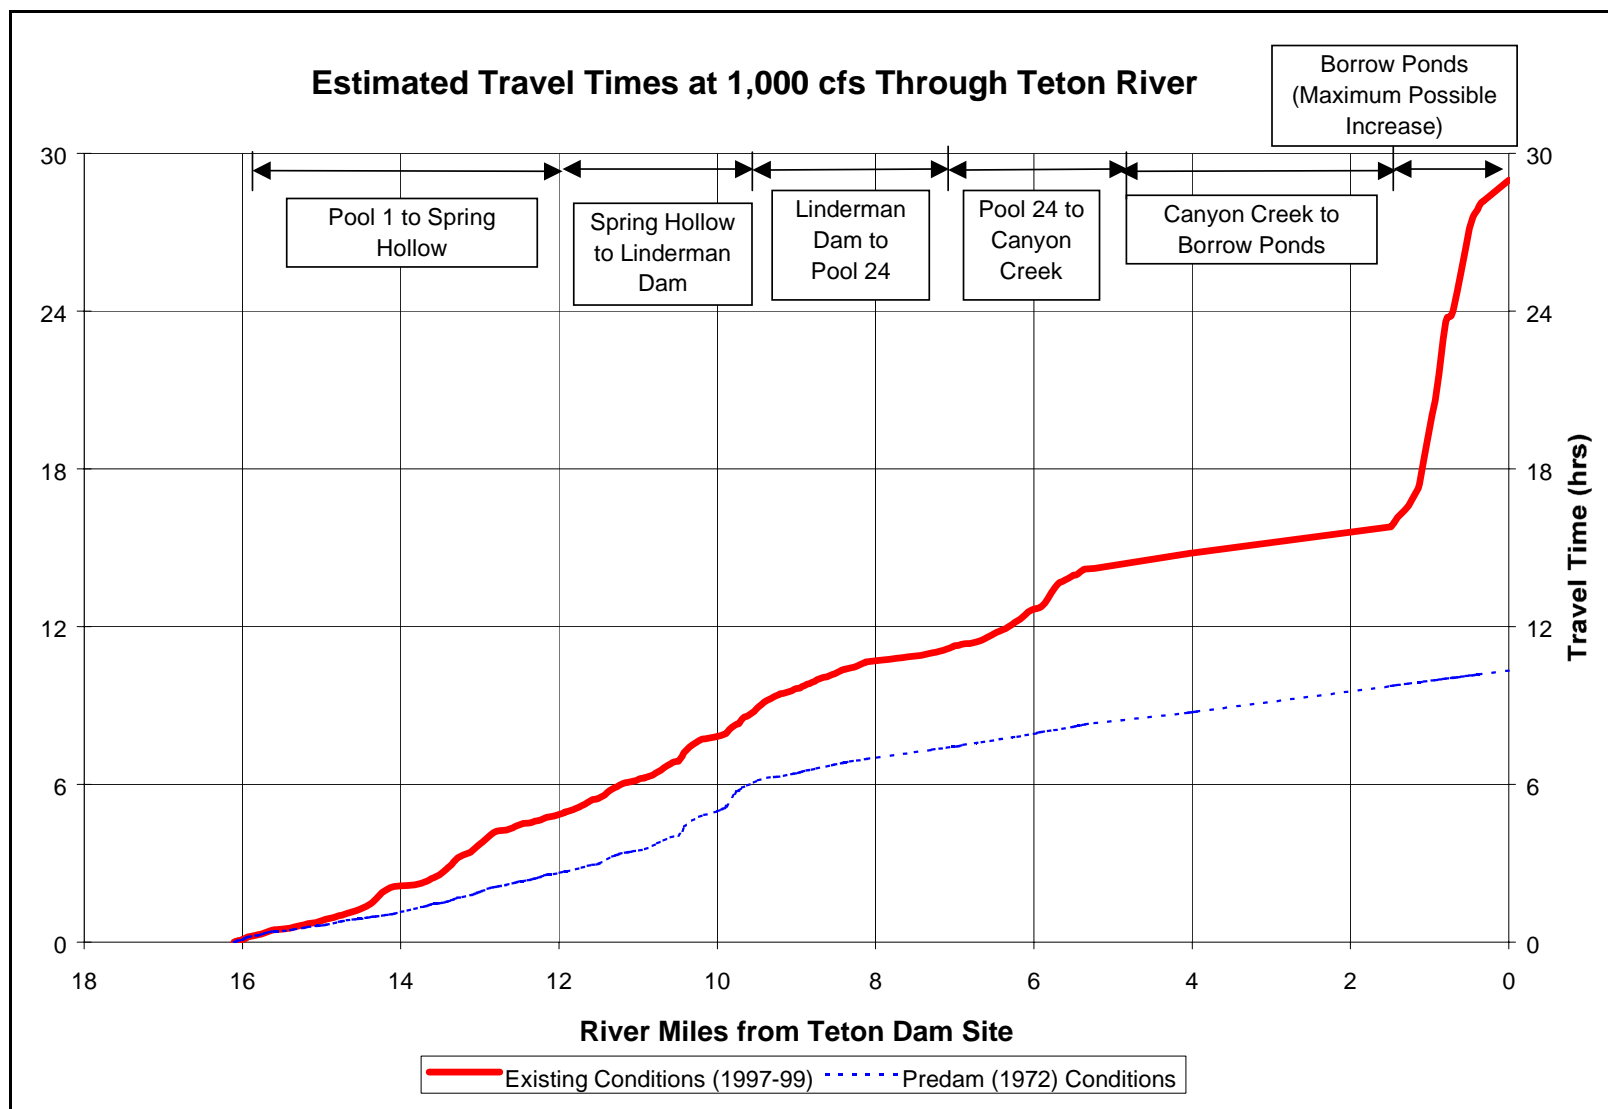
Travel time through the rapids is very fast, as expected, and travel time through the pools depends on both the length and depth of the pool. The deeper or longer the pool, the greater the travel time. The travel time through the Bitch Creek to Canyon Creek reach has increased the most between pool 24 and the confluence with Canyon Creek, where deep pools exist that did not exist prior to the 1976 landslides. The borrow ponds have increased the travel time through the last 1.5 miles upstream from the dam site by a maximum of 12.6 hours. However, the actual increase may have been less. This is because the hydraulic model did not include the river channel that can bypass flow around the downstream borrow pond. Further, because the model is one-dimensional, any potential eddy or density currents in the borrow ponds were ignored. Eddy or density currents in the borrow ponds would decrease the effective flow area through the ponds and increase flow velocity, which, in turn, would decrease travel time.

Figure 10.—Estimated water travel times corresponding to a typical summer discharge of 1,000 ft^3/s for existing (1997-99) and predam (1972) conditions in the former Teton Reservoir area.

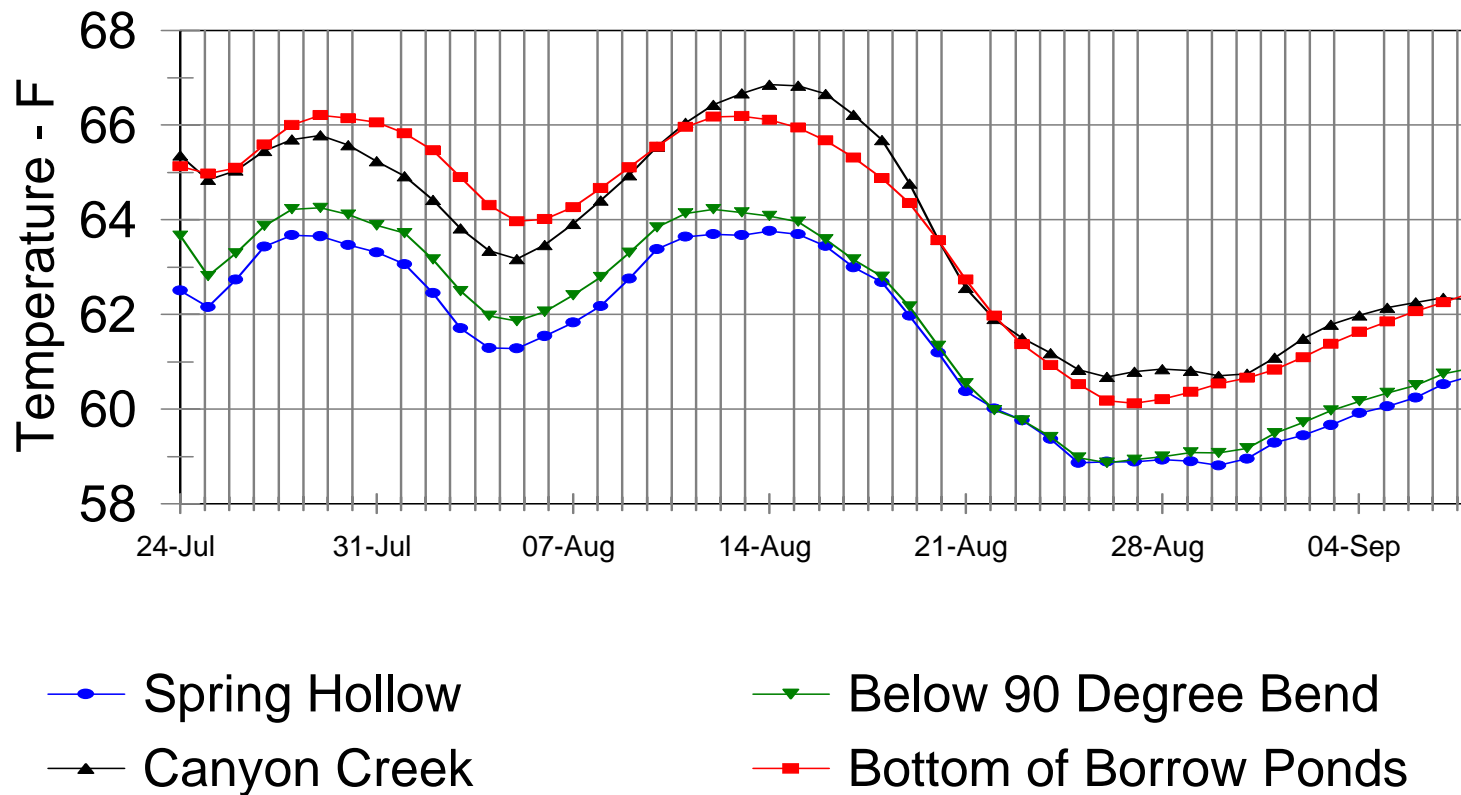
Increased temperature is postulated to result from the increased travel time, and shallow, lower velocity, larger surface area pools resulting from the many small landslides induced by inundation and dam failure that are partially blocking flow. Temperature data collection and analysis to determine likely increase in summer temperatures due to increased travel times in pools was performed during the summer of 1998 (Bowser, 1999) (figure 11). The construction and subsequent failure of Teton Dam has likely increased summer river water temperatures by 1 to 2 degrees F. Temperatures have increased because flows today move slower through the river pools enlarged by 1976 landslides and through the borrow ponds excavated for the construction of Teton Dam. The loss of riparian trees, especially in the reach downstream of Canyon Creek, also would have contributed to increased river temperatures. Suitable temperatures probably still exist in the deeper portions of the borrow ponds and river pools upstream of Canyon Creek. Most of the temperature gain occurs along the reach of river between pool 24 (7 ½ miles upstream of Teton Dam) downstream to the confluence with Canyon Creek, and in the borrow ponds.

Figure 11.—Comparison of mean daily water temperatures collected in the Teton River (July 24, 1998, to September 9, 1998) at the locations of Spring Hollow, Canyon Creek, just downstream from a large bend in pool 24, and at the downstream end of the borrow ponds (Bowser, 1999).
